DEPARTMENT OF TRANSPORTATION

Quality Assurance and Source Inspection

Contract #: 04-0120F4Cty: SF/ALA Rte: 80 PM: 13.2/13.9File #: 69.28**WELDING INSPECTION REPORT****Resident Engineer:**Siegenthaler, Peter**Address:** 333 Burma Road**City:** Oakland, CA 94607**Report No:** WIR-021898**Date Inspected:** 13-Mar-2011**Project Name:** SAS Superstructure**OSM Arrival Time:** 1500**Prime Contractor:** American Bridge/Fluor Enterprises, a JV**OSM Departure Time:** 300**Contractor:** Zhenhua Port Machinery Company, Ltd (ZPMC), Changxing Island **Location:** Shanghai, China**CWI Name:** Mr. Xu Tao**CWI Present:** Yes No**Inspected CWI report:** Yes No N/A**Rod Oven in Use:** Yes No N/A**Electrode to specification:** Yes No N/A**Weld Procedures Followed:** Yes No N/A**Qualified Welders:** Yes No N/A**Verified Joint Fit-up:** Yes No N/A**Approved Drawings:** Yes No N/A**Approved WPS:** Yes No N/A**Delayed / Cancelled:** Yes No N/A**Bridge No:** 34-0006**Component:** OBG**Summary of Items Observed:**

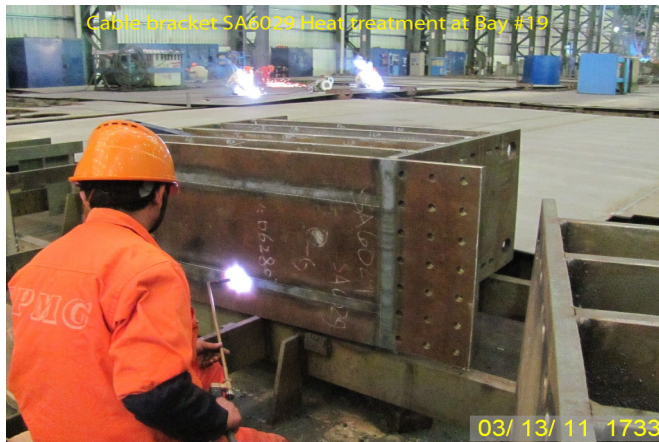
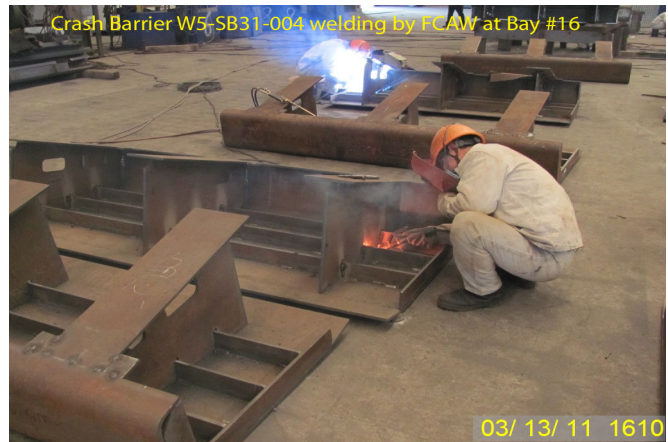
For further information see below pictures:-

Unless otherwise noted, all work observed on this date appeared to be in general compliance with the applicable contract documents.
